Supplemental Report

Bryson v. Rough Country, LLC

Mecanica Case Number: 22-3104

Date of Collision: March 15, 2020

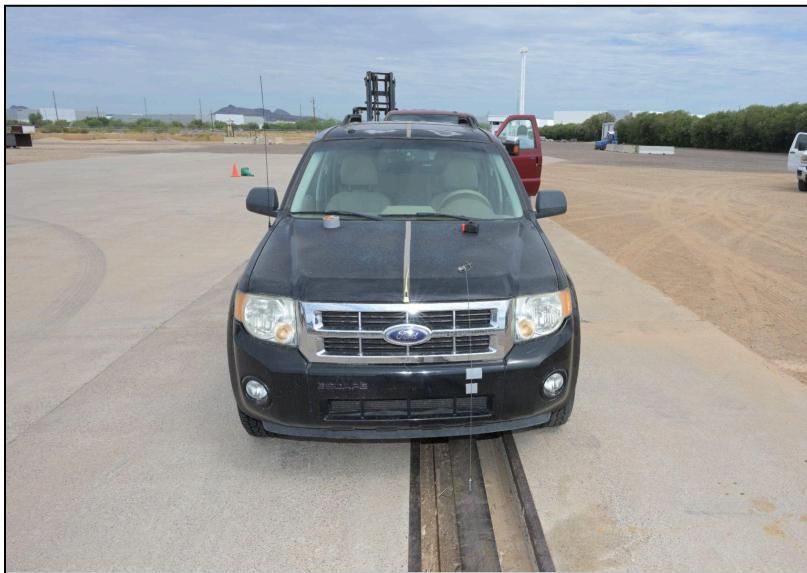
Figure 53: Front of an exemplar Escape with the crash rail centerline 10.9 inches left of Escape's longitudinal centerline.

Exemplar vehicles were also lined up to replicate the crash test alignment. The Escape was first aligned on the crash rail. Measurements were taken from the longitudinal centerline of the Escape 10.9 inches to the left on the front and rear bumpers. These points were then aligned with the crash rail centerline (**Figures 53 and Figure 54**). The front of the F-250 was then moved to the rear of the Escape, with the F-250's longitudinal centerline aligned with the crash rail centerline (**Figure 55**). In this configuration, the F-250's longitudinal centerline was just inside the left rear-window hinge (**Figure 56**).

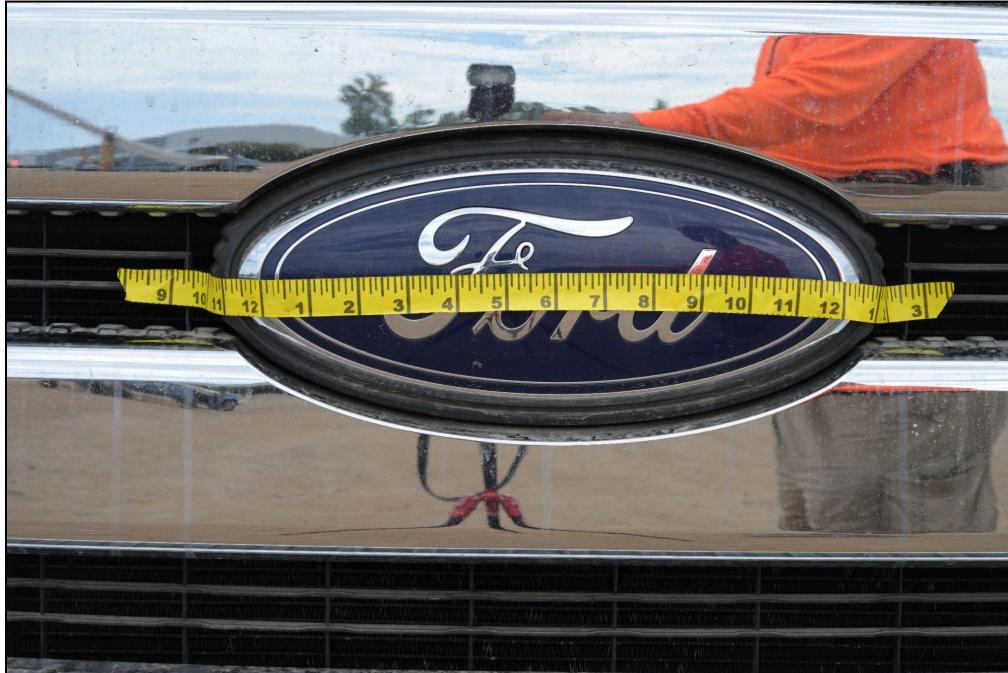
Figure 57: Width of the Ford logo on the F-250

The Ford logo at the front of the F-250 was approximately 12 inches wide, from one outer edge of the blue border to the other, shown in **Figure 57**. The center of the logo was six inches from either outer edge of the blue border. In other words, the '6' on the inch tape is the approximate middle of the logo shown in **Figure 57**.

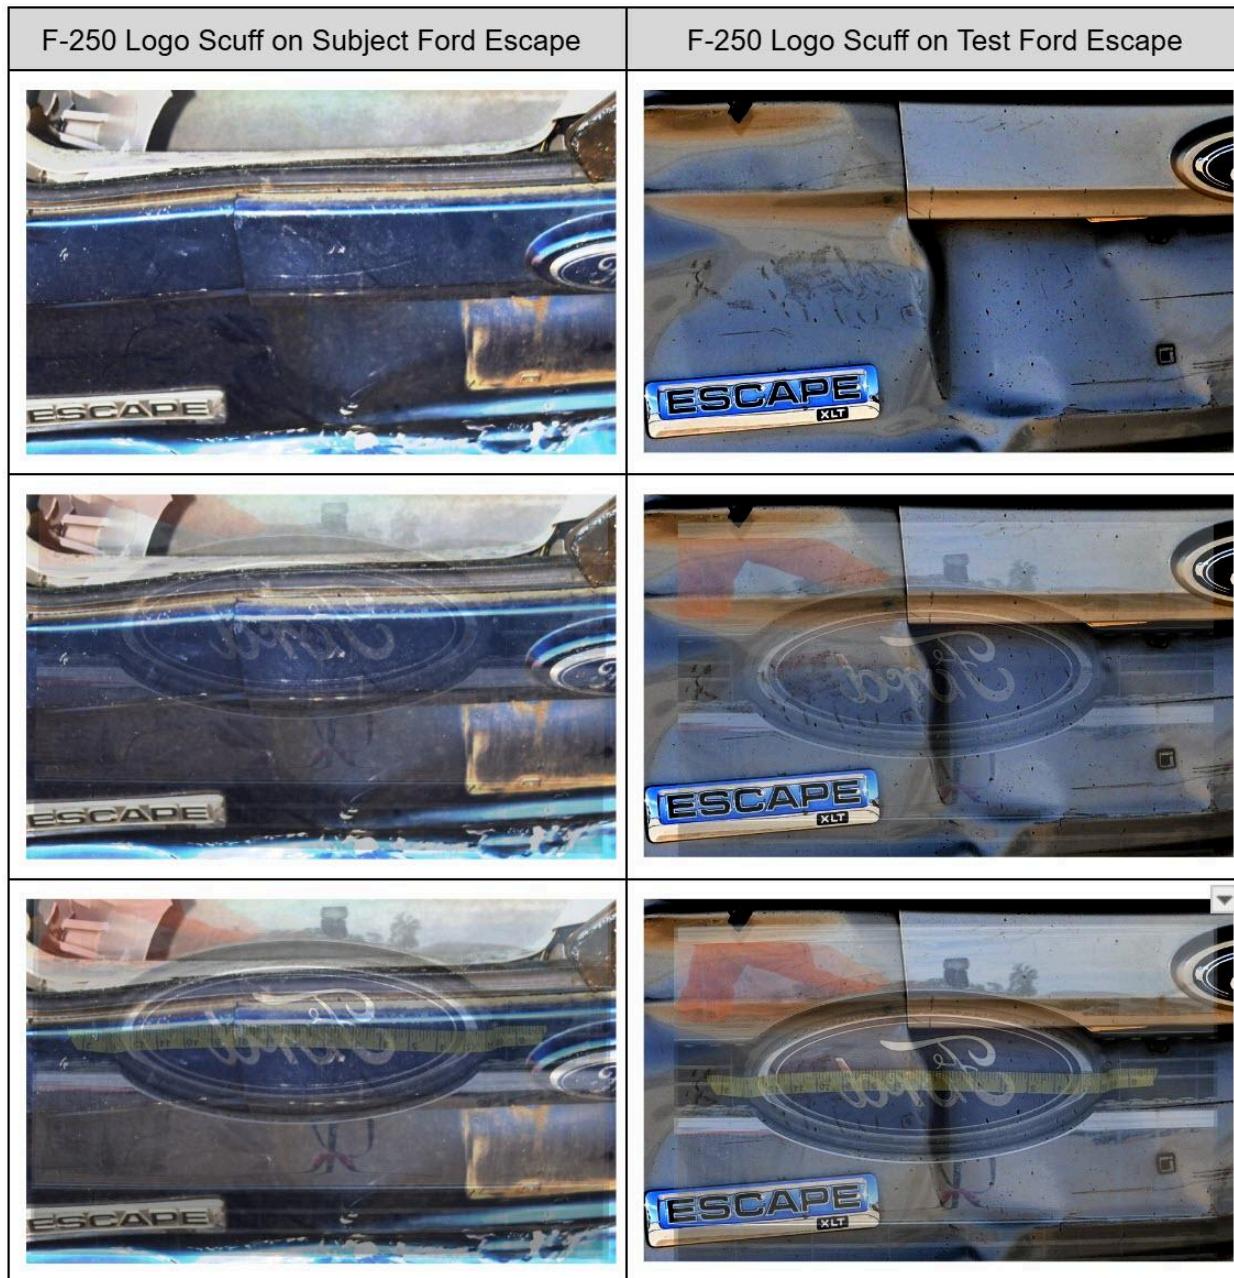
There were impressions, or scuffs, from a Ford F-250 logo on the Ford Escape from the subject crash as well as the Ford Escape used in the crash test. There was a trim panel on each Ford Escape located in the middle of the hatchback at the glass line, and the lower-left corner of this panel was used as a reference point on each vehicle to identify where the logo scuff was located.

There is no way to determine exactly when this logo impression was created during the interaction between the vehicles. They were not created at the initial point of impact since the F-250's front bumper would first contact the Escape. Also, note that these are complex 3-dimensional surfaces and 2-dimensional photos cannot place these marks more accurately than approximately a $\frac{1}{4}$ (0.25) inch. **Figure 58** depicts photos from both vehicles and the progression of images including the following:

Figure 58: Image overlays depicting F-250 logo scuff on Ford Escape.

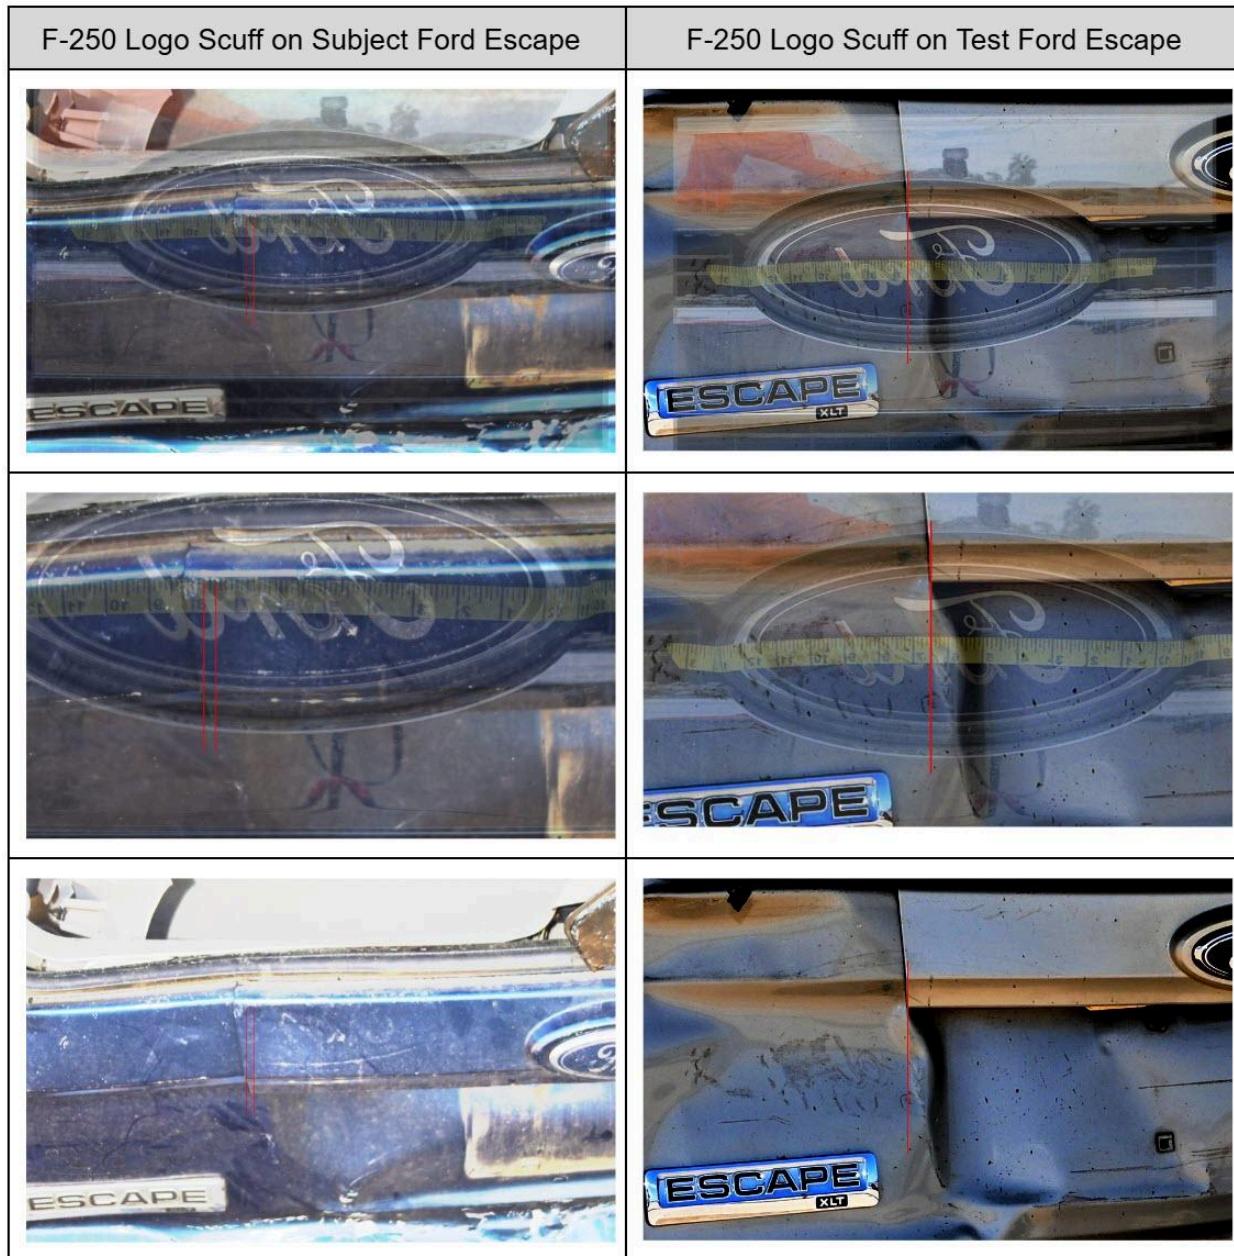
**Figure 59: Image overlays depicting F-250 logo scuff on Ford Escape with index marks.**

On the subject crash Ford Escape, the middle of the logo impression was made on the trim piece below the rear window. The left column of **Figure 59** shows the center of the F-250 logo overlay located between 1.5 to 1.75 inches toward the right of the reference point on the subject crash vehicle.

On the crash test Ford Escape, the middle of the logo impression was slightly lower than the trim panel. The right column of **Figure 59** shows the center of the F-250 logo overlay located approximately 0.5 inches toward the right of the reference point.

Utilizing the analysis documented in these images it appears that the logo scuff on the crash test Ford Escape was approximately 1 inch to 1.25 inches farther left from the longitudinal centerline than was the logo scuff on the subject crash Ford Escape. A portion of this difference may be explained by the rear hatch displacement to the right as shown in the point clouds and photos.

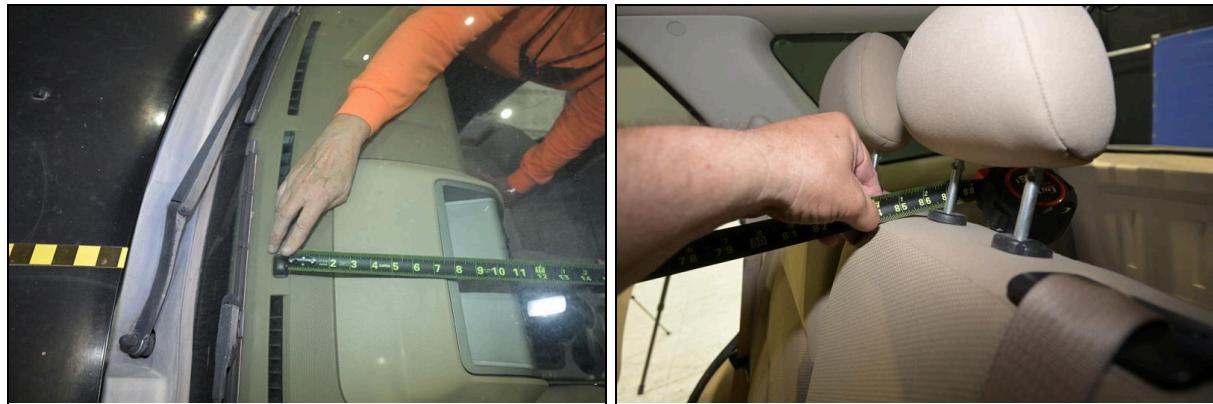
Figure 64: Measurement to upper middle of rear seatback in exemplar Ford Escape.

A measurement was made from the daylight sensor, located in the top middle of the dash, to the middle top of the rear seatback. The reference point on the rear seatback was a black plastic trim around the right headrest post. **Figure 64** depicts this measurement in the exemplar vehicle and **Figure 65** depicts this measurement in the test Ford Escape. This part of the rear seatback was displaced forward approximately 10 inches.

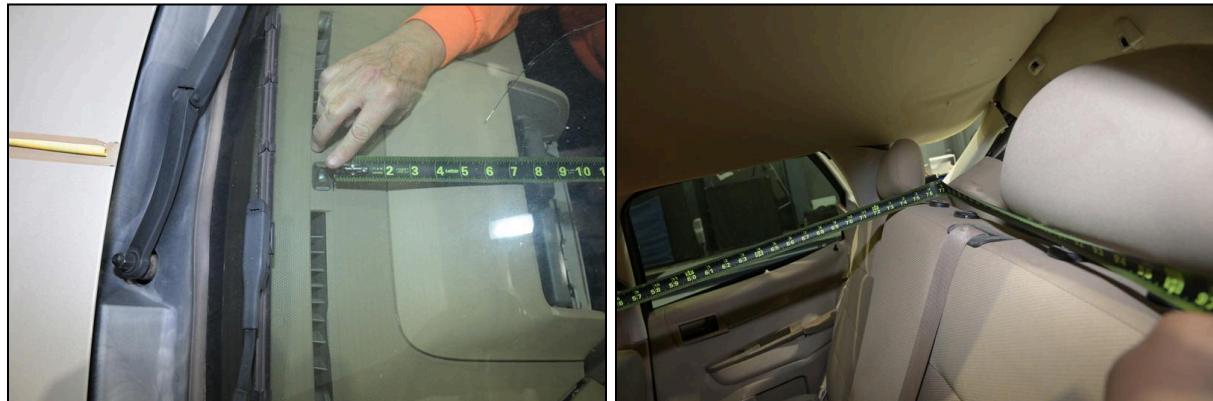
Figure 65: Measurement to upper middle of rear seatback in test Ford Escape.

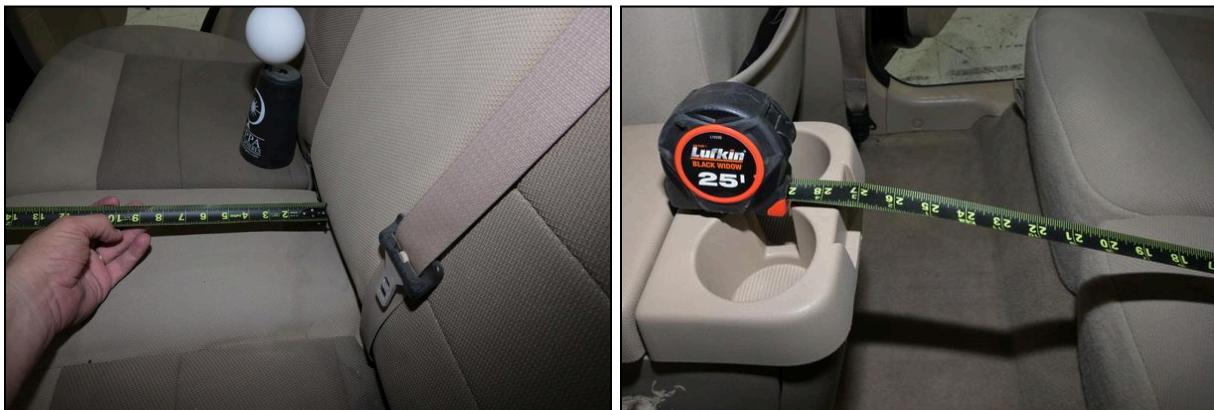
Figure 66:- Measurement to lower middle of rear seatback in exemplar Ford Escape.

A measurement was made from the aft edge of the center console to the lower middle of the rear seatback. **Figure 66** depicts this measurement in the exemplar Ford Escape and **Figure 67** depicts this measurement in the test vehicle. This part of the rear seatback was displaced forward approximately 10.5 inches. Note that this measurement also includes more of a vertical component in the exemplar vehicle, thus the actual displacement would be slightly less.

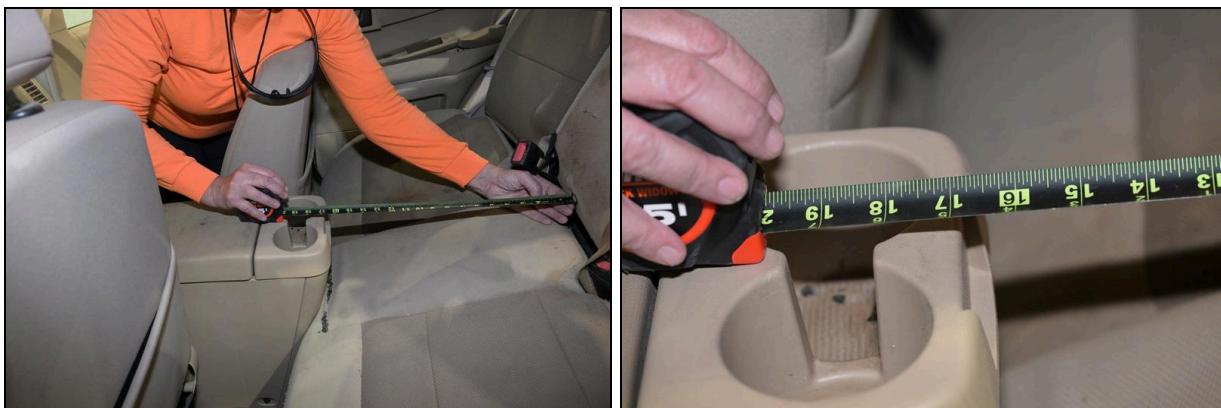
Figure 67: Measurement to lower middle of rear seatback in test Ford Escape.

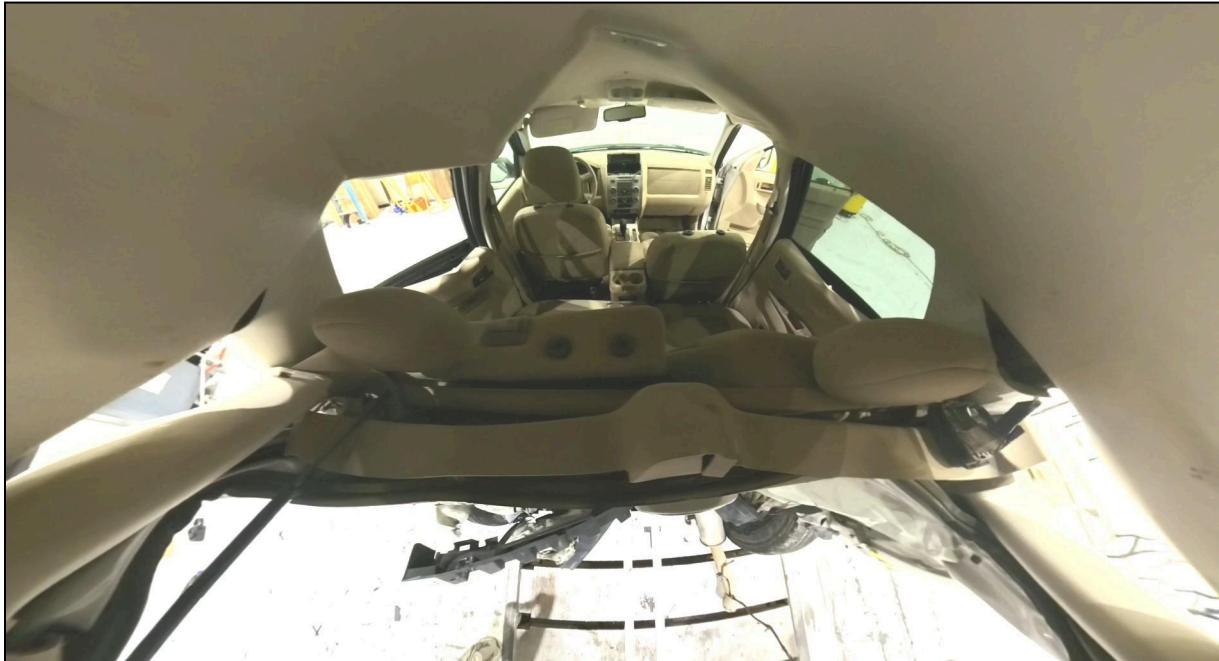
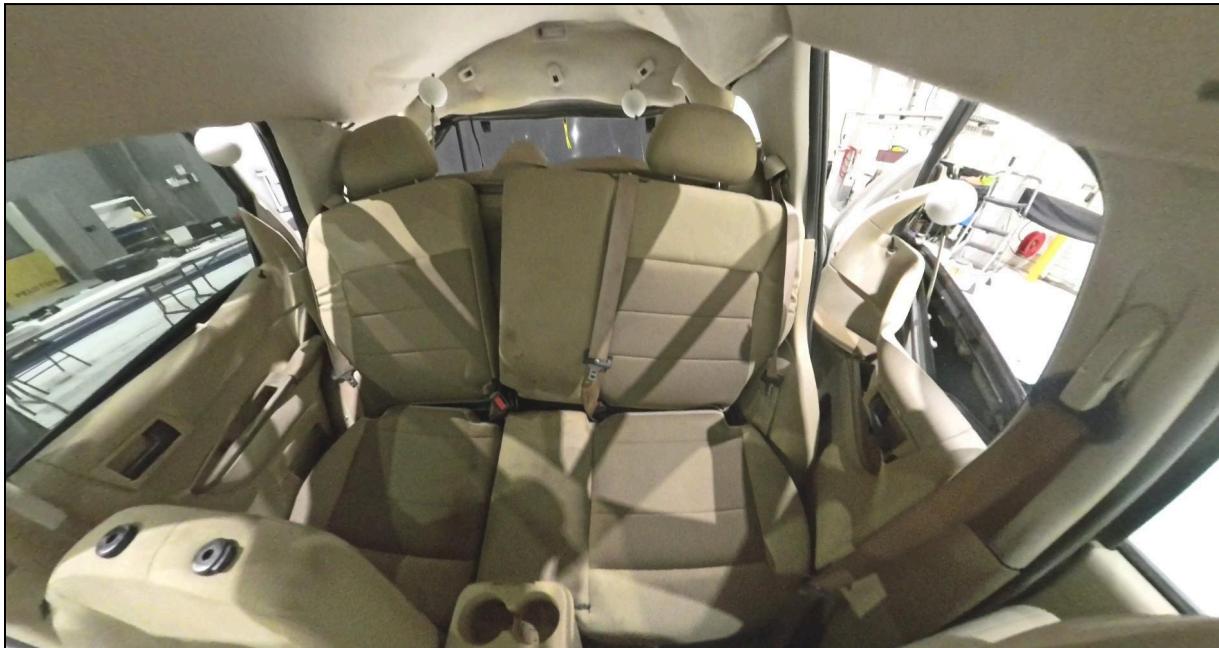
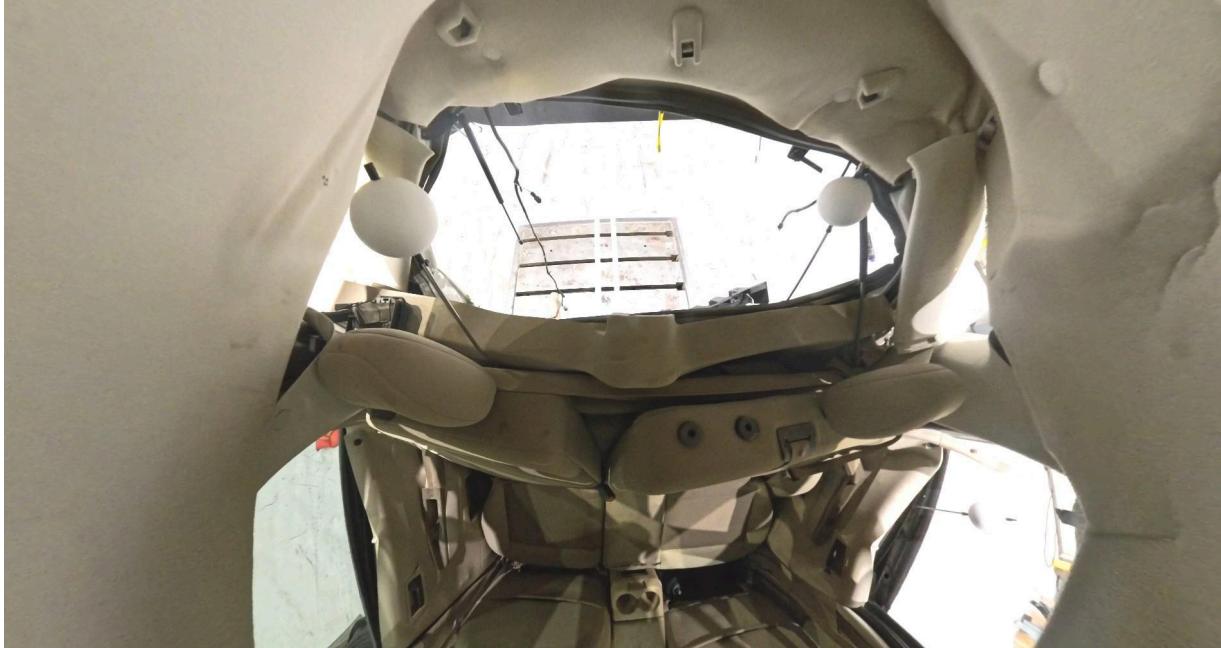
Figure 68 through **Figure 70** depicts still images extracted from a 360 video of the seatback area of the test Ford Escape. It can be seen that the seatback is displaced and distorted. In addition, these images show that the interior of the vehicle hatch made contact with the aft portion of the rear seatback.
